Evaluation of the wear between matrix® titanium implants and directly screw-retained zirconia crowns.

Study executed by renowned and independent lab RMS foundation.

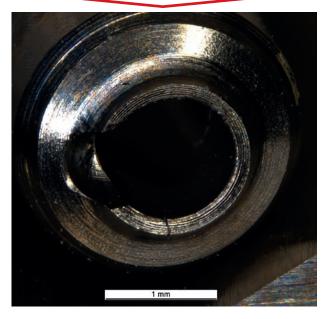
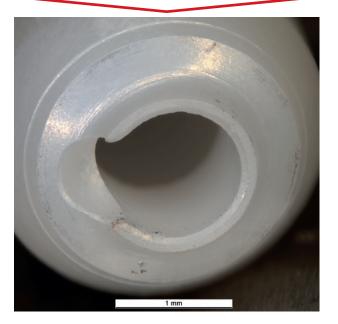
Impeccable titanium and zirconia matrix® crown interfaces after patient's lifetime simulation.

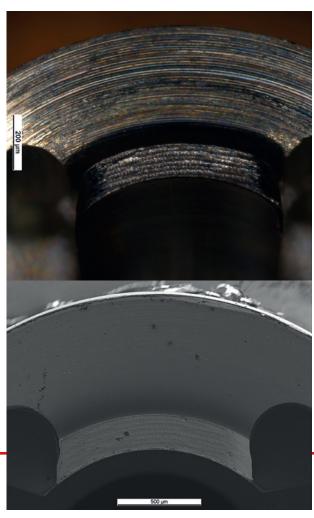
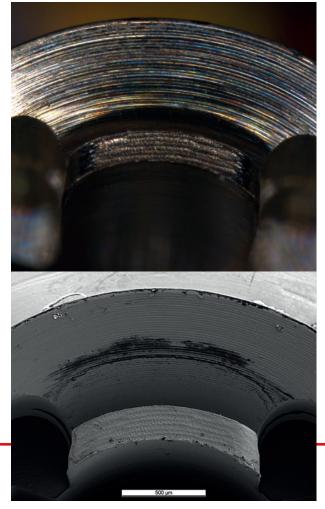
Impeccable matrix® implant interfaces, connected both to titanium as well as zirconia matrix® crowns, after patient's lifetime simulation. Documented by bi-focal microscopy and scan electron microscopy.

All components remeined impeccable after patient lifetime simulation.

No wear observed even with highest magnifications.
